# OPERATION CROSSROADS

## BUREAU OF SHIPS INSTRUMENTATION GROUP

SECTION X

### Shock Measurements

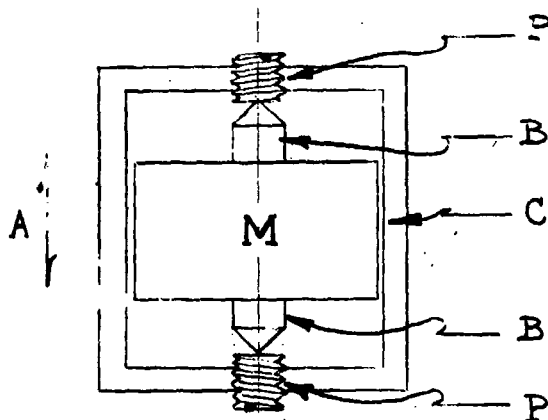
The indenter gage was designed as a peak-reading accelerometer. Figure 4 shows the essential details of such a gage. The mass M is guided by case C and rests against the hardened steel pins B. The end of B in contact with M is cut off square, but the other end has a 90° conical point and just contacts the flat surface of a soft aluminum plug P.

When the case C is accelerated up or down, the inertia of M causes a cone point to be pressed into its aluminum plug. It has been shown for static tests that the depth,  $d$ , of penetration of the cone point into the aluminum is related to the applied force  $F$  by the formula  $F = Rd^2$  where  $R$  is an empirical constant. Further, the depth of penetration is uniquely related to the crater diameter of the impression. Assuming that the static law  $F = Rd^2$  applies under dynamic loading conditions, we can find the peak acceleration of the mass M from a measurement of crater diameter and a curve of  $F/M$  versus crater diameter. However, we are interested in the peak acceleration of the gage case, not that of the internal mass. While the two are equal for a gradually attained steady acceleration, they can be very different for rapidly fluctuating accelerations.

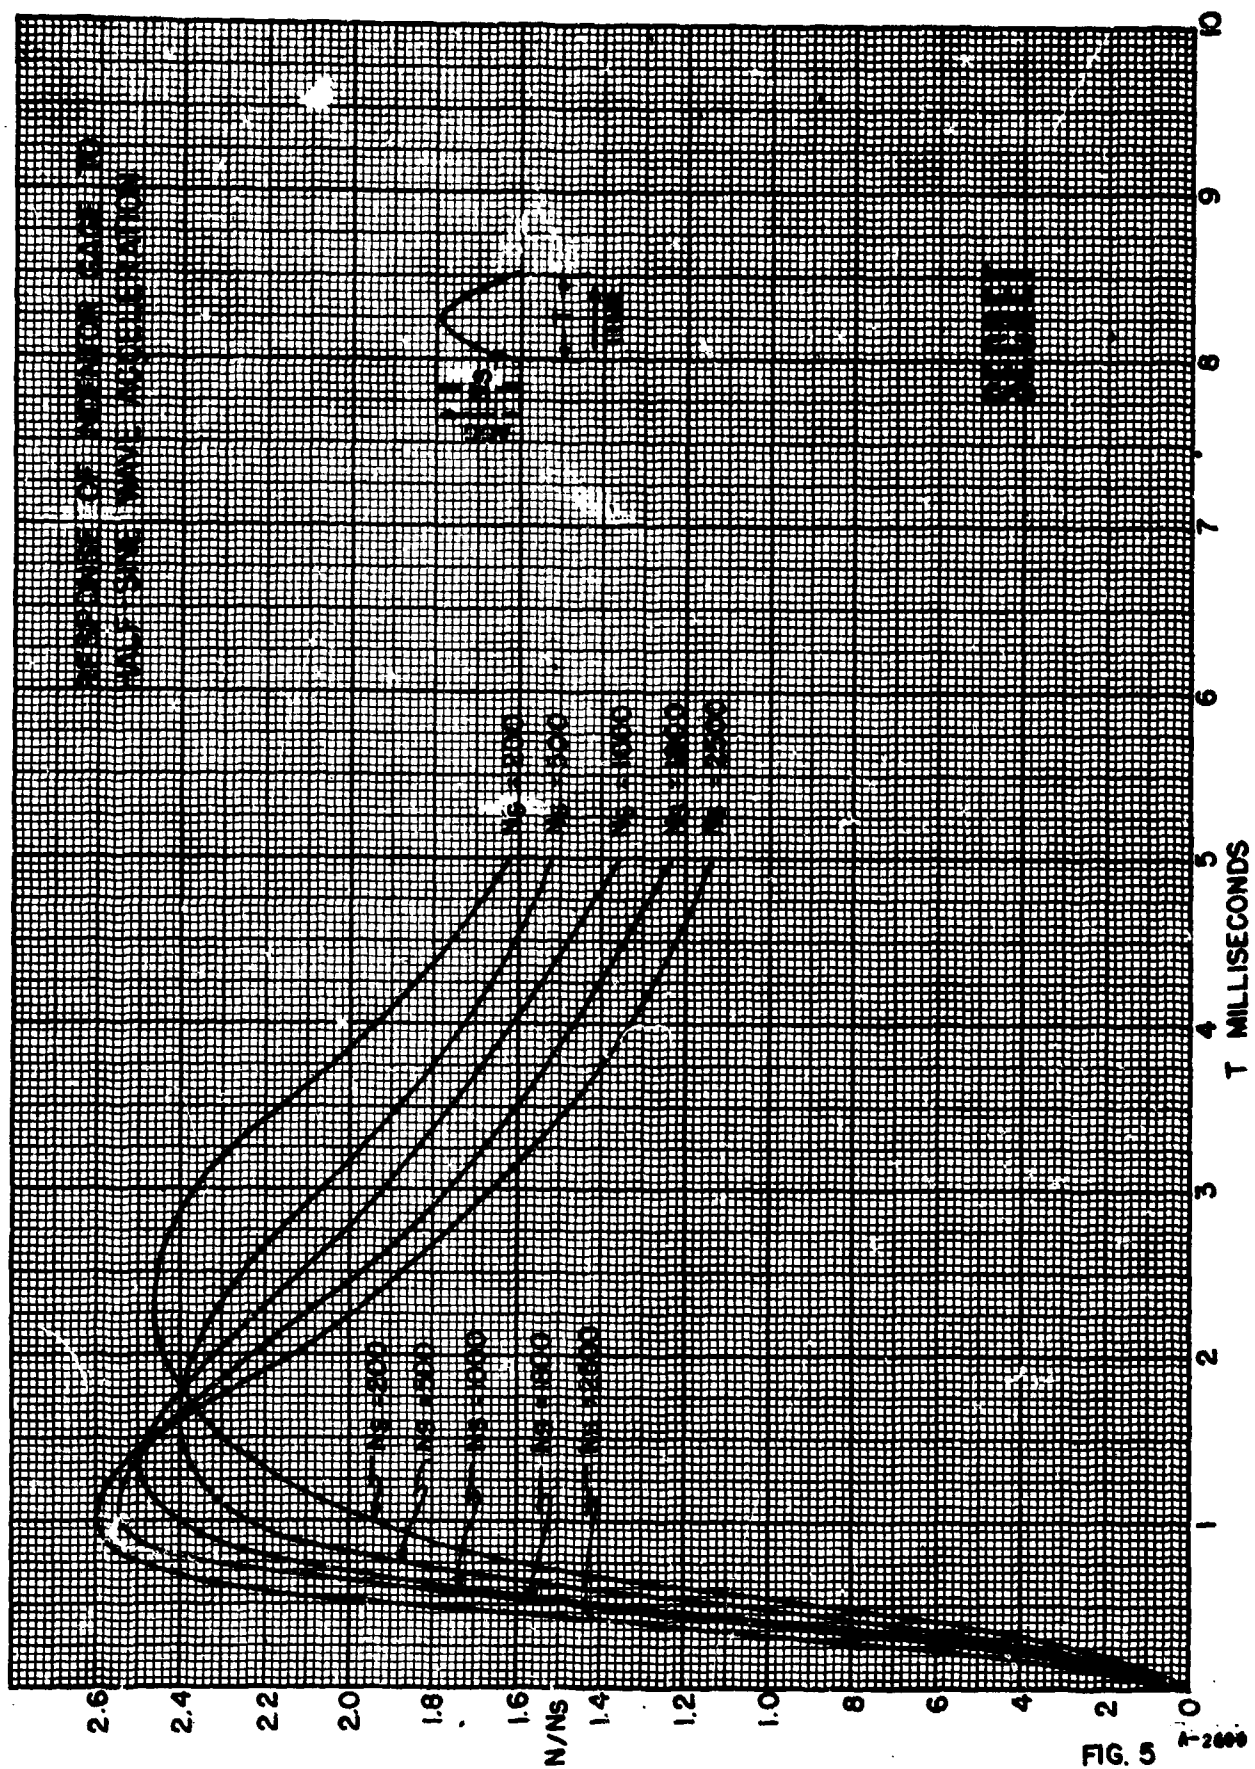
FIG. 5

A theoretical analysis of an indenter gage with values of  $M$  and  $R$  the same as those for the gages used at Bikini has been made by Dr. Paul Symonds of NRL for the case when the gage base undergoes a half-sine wave pulse of acceleration with a peak value of  $A_p$  and a duration  $T$ . The curves resulting from this analysis are shown in Figure 5.

The gage reading is too low for  $T < 1/2$  millisecond and is about 2-1/2 times too high for  $T$  in the vicinity of 1-4 milliseconds. At larger values of  $T$ , the reading approaches the true value.

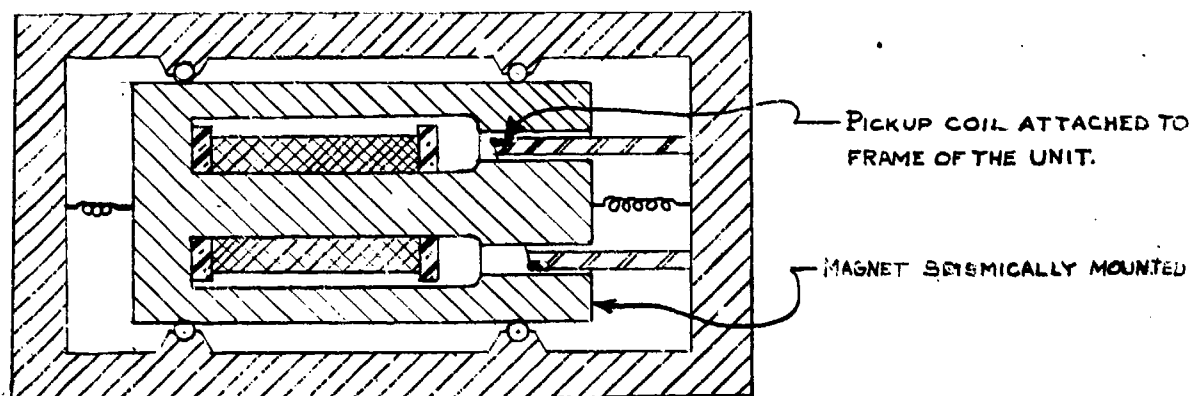
Figure 6. "British Type Velocity Meter."

The velocity pickup used was originally designed by the British and was extensively used on their "Cameron" trials. Modifications of this instrument were made by the David Taylor Model Basin group and a more detailed description of this instrument can be found in their reports. The essential features of the unit are

illustrated in Figure 6. The velocity pickups and their recording systems reported here were operated by personnel from the Bureau of Ships and from the Norfolk Navy Yard.

In inspecting the velocity meter records, the effect of the springs and bottoming of the magnet must be considered. The springs cause a low frequency oscillation of the record at less than 10 cps. When the magnet bottoms against the base of the meter, a sudden reversal of the signal occurs which is rather easy to detect. The stop in the other direction is the relatively flexible top of the meter cover which reverses the signal in a time which is not short relative to the shock motion changes. The magnetic field at the pickup coil drops from full strength to about 50 per cent of full strength as the magnet moves through the last 1/8" to the top stop. The effect of this is to make the meter cover seem even more flexible and make this bottoming difficult to detect. The magnet bottoms after traveling zero or two inch (nominal travel between stops) after a previous bottoming. The travel to a stop from the rest position of the magnet is about one inch. By integration of the velocity-time record, the times at which bottoming will introduce a spurious record can be found. One can also find the direction of motion with respect to the front and back of the pickup unit, by noting whether a velocity results in a hard or soft bottoming of the meter.
